TIVAR® 88-2 Eight Million Tons Later AEP Glen Lyn Power Plant Railcar Receiving Hopper Case History

APPALACHIAN POWER COMPANY / GLEN LYN PLANT

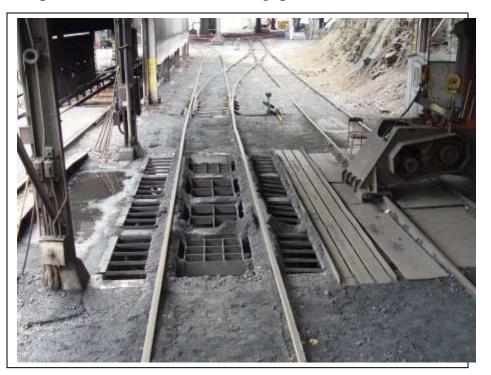
All of the coal arrives by train in 100-ton bottom dump railcars. These railcars unload into a single pyramidal shaped in-ground bunker that measures approximately 21' x 17' at the top and has a 6' x 3' 6" discharge outlet. The vertical height of the hopper is approximately 8' 6". The angles of the sloping walls are 45° and 48° respectively which make the valley angles less than 35° . The A36 carbon steel hopper is designed to discharge at 700 tons per hour with an annual throughput of 700,000 tons.

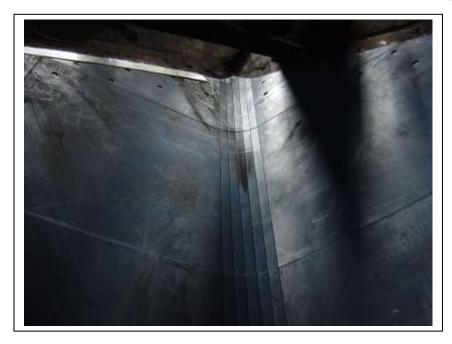
The SystemTIVAR® Engineering team designed 5/8" thick TIVAR® 88-2 oversized panels that would be attached in a "drape-hung" method at the top of the hopper using mechanical fasteners. The corners were score-cut to enable the liner to bend into the corners and form radius clean-out plates.

This design rounded off the existing square corners and facilitated smooth, fast coal flow in the shallow valley angles. T-profiles were incorporated to permit the oversized panels to expand and contact freely, eliminating any possibility of the liner buckling due to expansion. To complete the installation, a stainless steel leading edge protector was welded above the liner. The leading edge protector prevents the coal from migrating behind the liner and the T-profiles that are located on the center hopper walls. The TIVAR® 88-2 liner system was installed in October 1997.

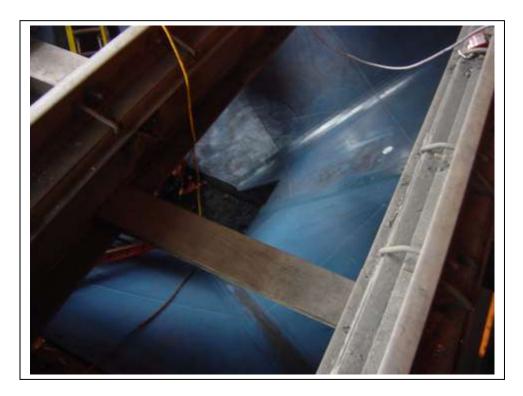
During the past 12 ½ years over eight (8) million tons of coal have passed through the Glen Lyn railcar receiving hopper. During this time the TIVAR® 88-2 liner performed above all expectations. Operators are no longer required to rod the coal to facilitate discharge resulting in no lost time injuries due to "punching coal" at the bunker. The freezing of the coal to the substrate was completely eliminated. The two units were never curtailed during this time due to lack of coal coming from the receiving hopper.

Time has now come for the replacement of the TIVAR® 88-2 liner. While still functioning well, areas around the discharge are worn. Due to the success of the liner, AEP has opted to have the SystemTIVAR® Engineering Group install a new TIVAR 88-2 liner. The liner system will be installed in May 2010 and is ready for another eight million tons.
