TIVAR® 88-2 replaces Stainless Steel in Dust Collection System

By: Carolyn Busack, Steve Honabarger and Ron Mesing

September 30, 2011

This paper details how solutions to dust collection challenges in the STP (sludge treatment process) resulted in a new application of TIVAR® 88-2 material at an AEP power plant in Ohio.

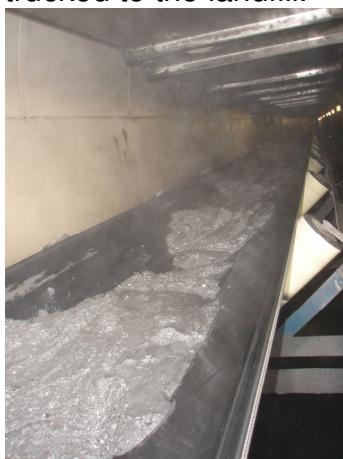
Figure 1 – Scrubber sludge after it has been mixed with fly ash and lime

For the past 30 years, pug mills have been used to mix calcium sulfite (scrubber sludge) with fly ash and lime to stabilize the material. After the material is discharged from the pugmills, the mixture is transported by conveyors (Fig. 1) to a concrete pad and then trucked to the landfill.

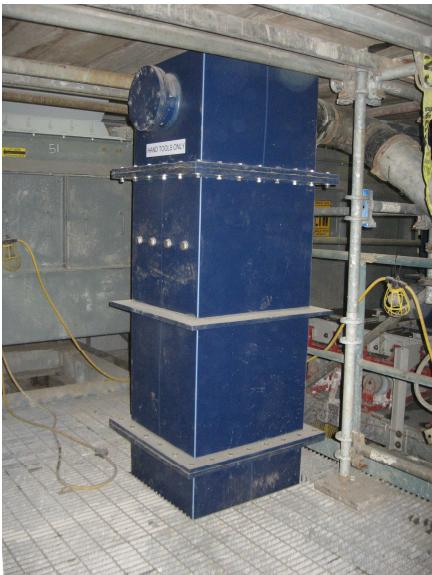
With these challenges in mind, AEP engineers and SystemTIVAR® Engineering designed a complete duct system that incorporated small duct sections, flanges, gaskets, stainless steel hardware, inspection doors, impact plates, test ports and inlet and outlet ducts (Fig. 2).

Figure 2 – Dust duct

The expansion and contraction issue was addressed by incorporating expansion joints at the critical connection points within the system. The expansion joints permitted the entire system to “float” and move freely, preventing the fractures and/or cracks that would occur if the system was fixed against movement.

In designing for the negative pressure, the ducts and hoods had to be fabricated in such a way as to create a leak proof system that would maintain a 3500 CFM air flow. The TIVAR® 88-2 walls were made thicker than the standard 11 gage (approximately 1/8" thick) stainless steel walls to prevent the duct from collapsing under the negative pressure. The square duct sections were fabricated using 1/2" thick TIVAR® 88-2 material. Three-quarter inch thick flanges were fabricated and extrusion welded to the duct sections at the joints. The length of each section was limited to between 2 ft. and 4 ft. long to facilitate the installation of the sections between floors.

To create a leak-proof construction, the bodies of the duct sections were extrusion welded on the inside, and neoprene gaskets were used between each flanged section of the duct to make the joint airtight. TIVAR® 88-2 inspection doors and inlet and outlet ducts were located at strategic areas. To prevent loss in pressure drop and possible dusting, neoprene gaskets were used to seal access doors to the duct sidewall. In addition, the HVAC (heating ventilation air conditioning) engineers needed a means to easily measure the air flow in the dust collection hoods. Hence, four (4) access ports were incorporated into the dust collection hoods to allow insertion of instruments to measure air flow.

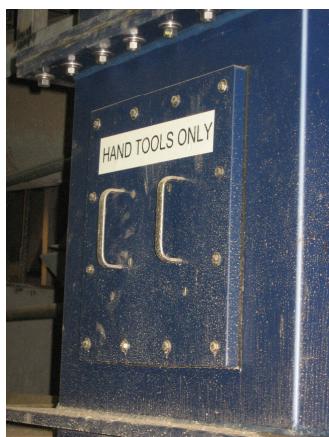
Stainless steel handles were installed on the lightweight access doors so they could be handled easily and without damage to the Tivar (Fig. 3).

Figure 3 – Dust duct access door

One of the concerns with using a “plastic” structure for the main body of the duct was the possibility of torquing fasteners too tight and stripping the “plastic” threads when reassembling the access doors. Stripping the threads in the main body of the duct would lead to loose connections and cause leaks in the system. To eliminate this possibility, stainless steel threaded inserts were incorporated at the doors and ports. Although this design minimized the stripping potential, signs were placed on the duct body instructing personnel to use “hand tools only.”
